Manhole Inspection Summary

Manhole # S17K__006MH

Insp Date: **4/10/08 11:00 AM**

Location Address: **135 warwick st**

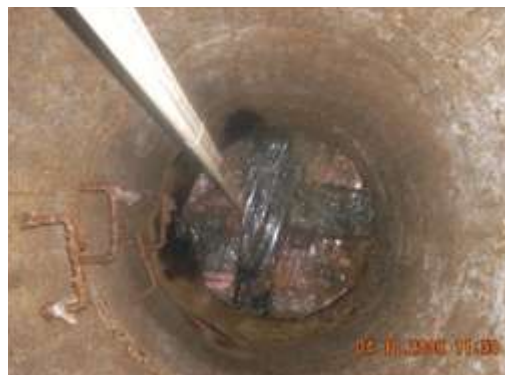
Top View

evidence of surcharge

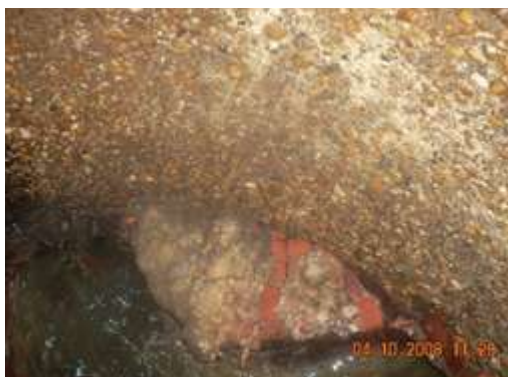
Defect 3

Condition: ☐ Sound ☐ Cracked ☐ Root Intrusion ☐ Deteriorated ☐ Leaks ☒ **Debris**

debris on bench

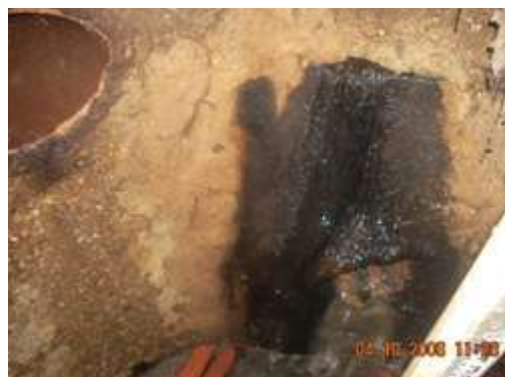
Defect 2

Condition: ☐ Sound ☒ **Cracked** ☐ Root Intrusion ☐ Loose Brick ☒ **Deteriorated**

Infiltration: ☐ None ☐ Joint ☒ **Cracks** ☐ Mortar ☐ Roots ☒ **Wall**

infiltration of barrel wall from crack,
deterioration of barrel wall

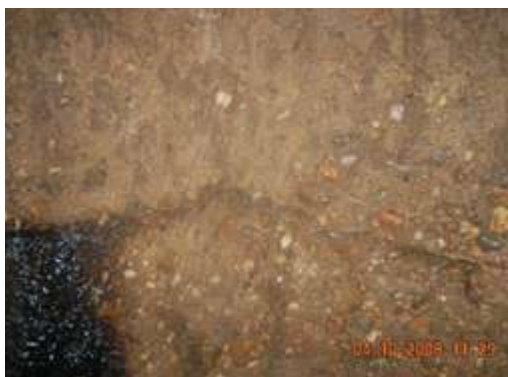
Defect 1

crack in barrel wall

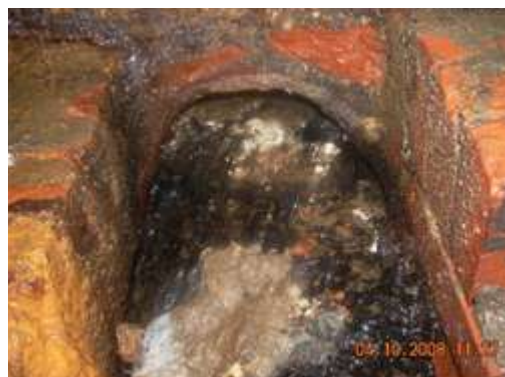
Defect 4

Condition: ☐ Sound ☐ Cracked ☐ Root Intrusion ☐ Deteriorated ☐ Leaks ☒ **Debris**

channel cond debris

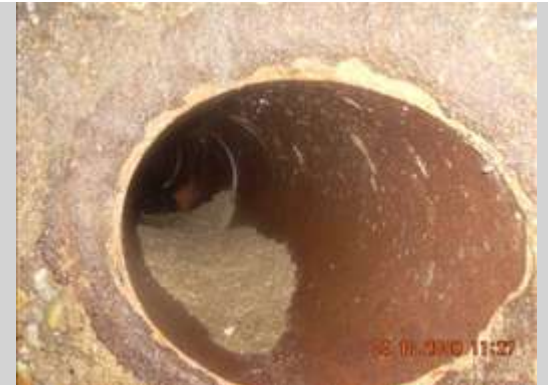
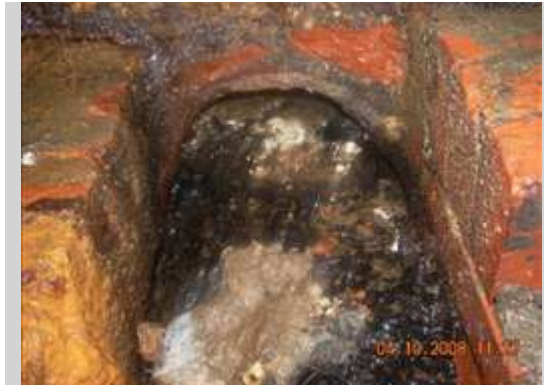
6 O'Clock Inflow

channel debris

Deposits: ☐ None ☒ Mud ☒ Sludge ☐ Debris ☐ Grease

Silt Depth: **8** (in.) Deposits Extent: **Heavy**
